1. Name Neelsville Presbyterian Church
2. Planning Area/Site Number 19/5
3. MNCPPC Atlas Reference Map 7
F-12
4. Address 20701 Frederick Road, Germantown
5. Classification Summary

INVENTORY FORM FOR STATE HISTORIC SITES SURVEY

Neelsville Presbyterian Church

20701 Frederick Road

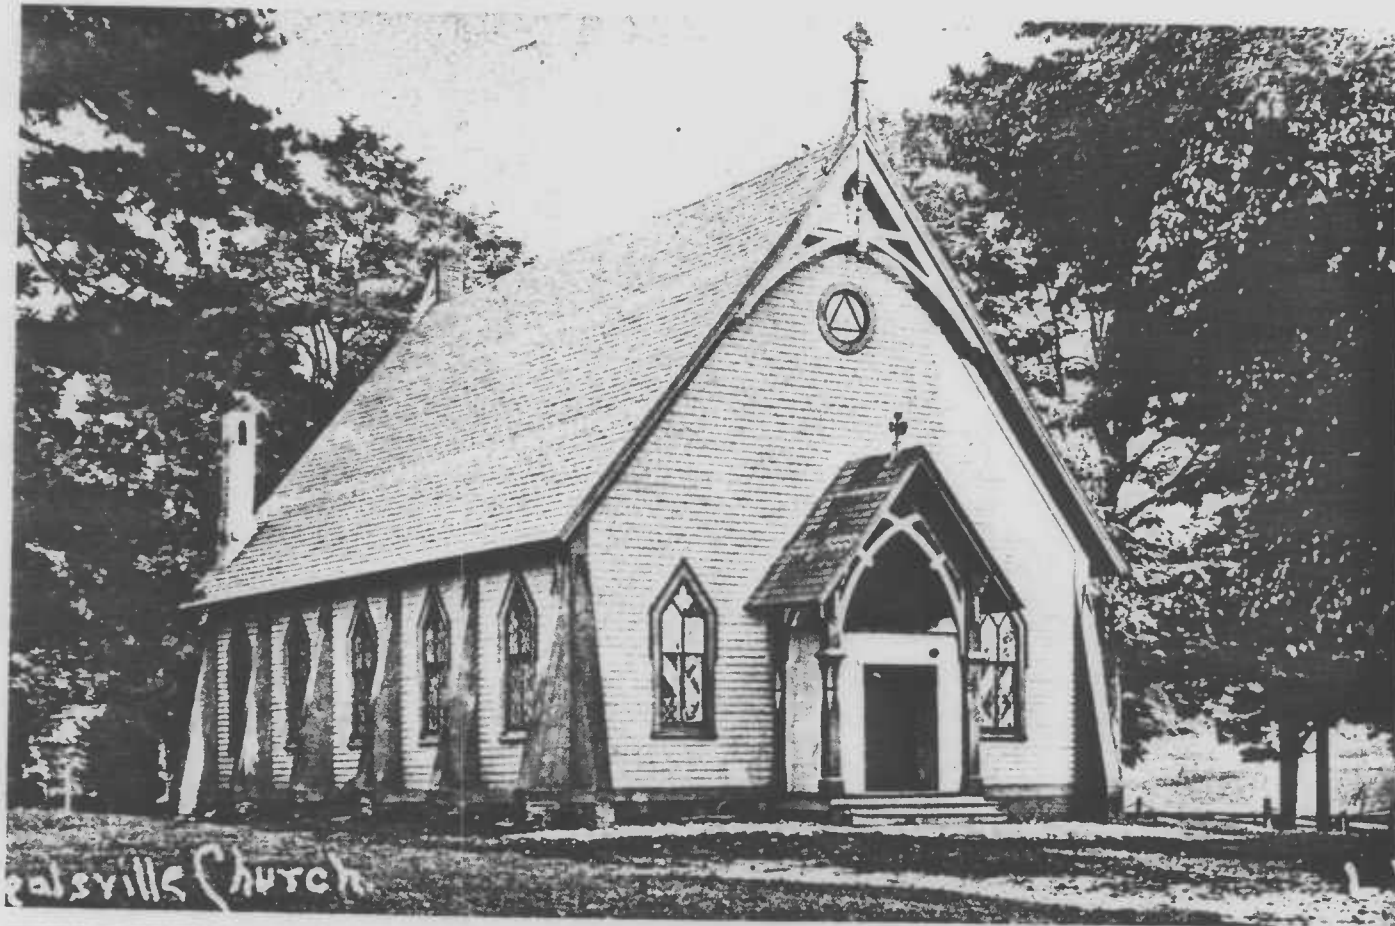
In 1849 a road was constructed in Montgomery County connecting two Presbyterian congregations, one at Nealsville (later Neelsville) and one at Darnestown. Later, the stained-glass windows and expensive archi-

tectural details were added to the Neelsville Presbyterian Church, reflecting the prosperity of the railroad era. Courtesy of Idella Leaman

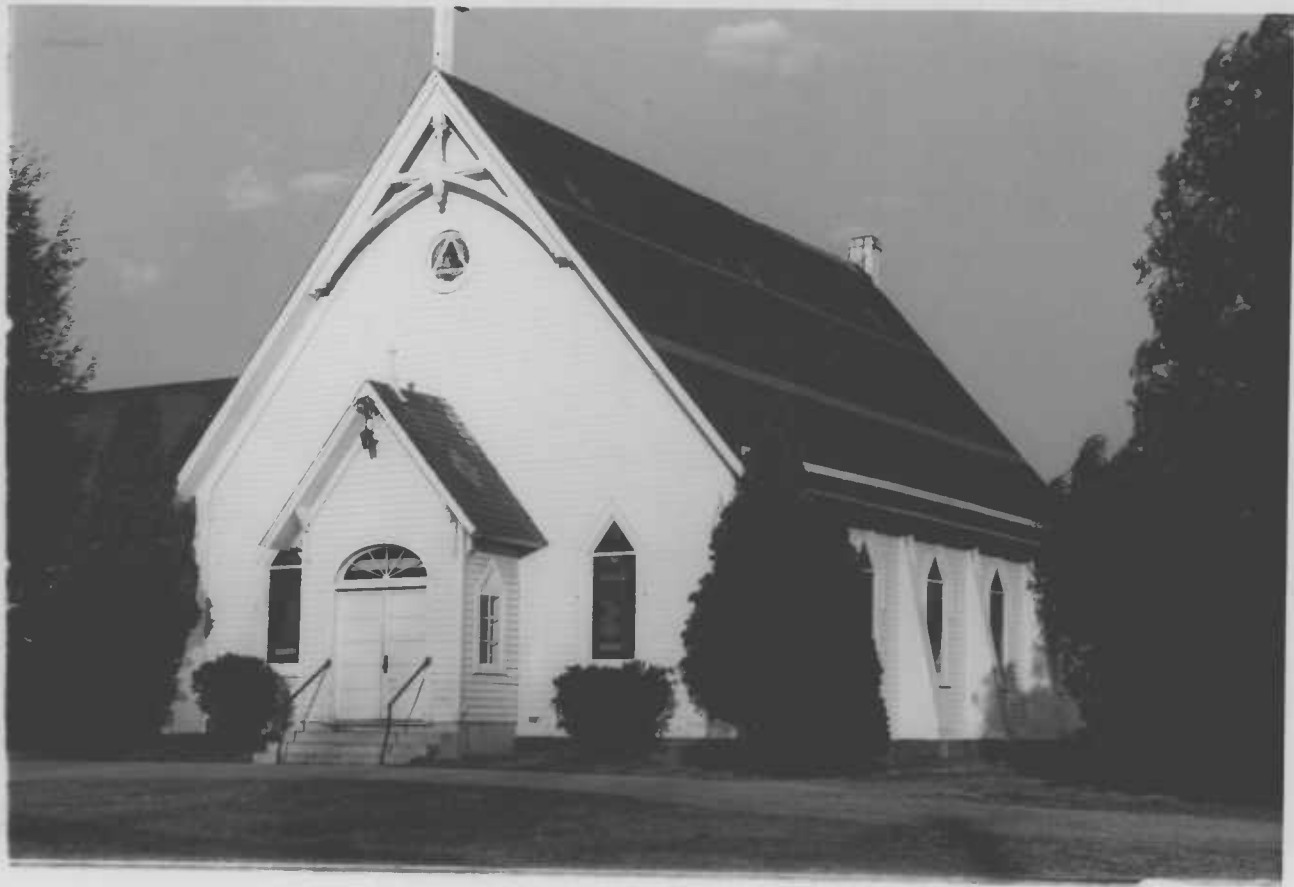
NAME #19-S NEELSVILLE PRESBY. CHURCH

LOCATION RTE. 355 + RTE. 118, NEELSVILLE, MD.

FACADE SW.

PHOTO TAKEN 12/9/74 M. DWYER
